ALBUM FOR 1906

Ambursen Hydraulic Construction Company

176 Federal Street, Boston, Massachusetts

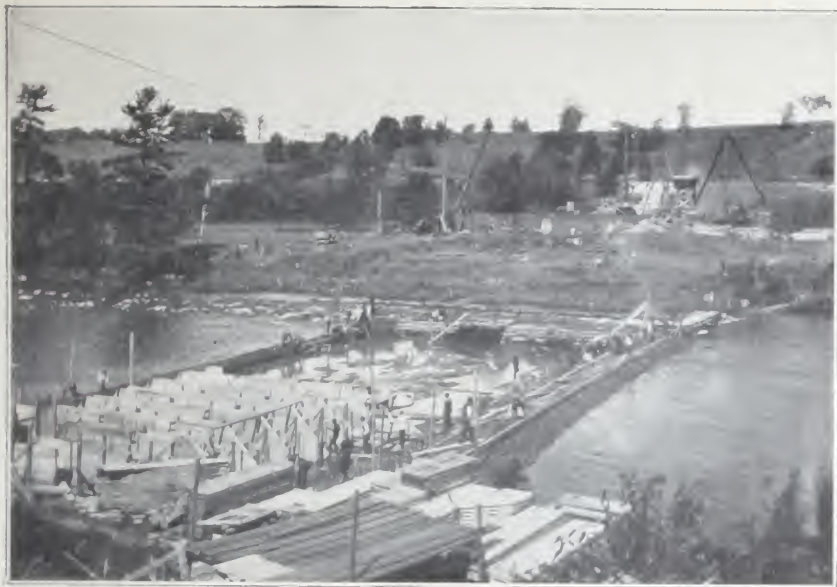
PLATE 3

PLATE 3. This photograph was taken on September 30, three days after commencing to set up the temporary forms. The foundation is on Hudson River shale. A trench 5 feet wide and 3 feet deep receives the cut-off wall at the heel of the dam. No excavation was made for the buttresses, the only preparation being to wash the silt and slime out of the crevices of the rock by a water jet.

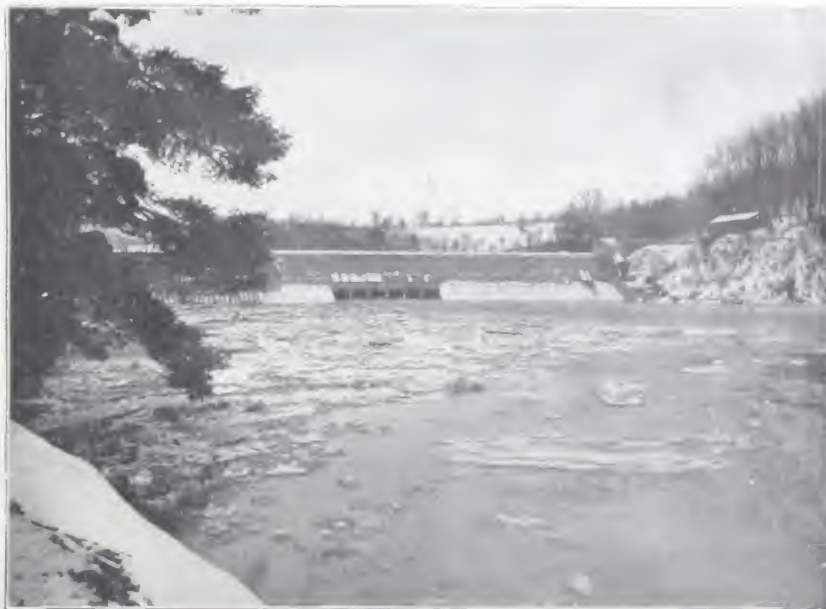
PLATE 4

PLATE 4. In this view looking up stream the dam is shown as completed except for the temporary openings through the apron, through which the river is discharged before closing. These openings are subsequently closed and the apron made continuous.

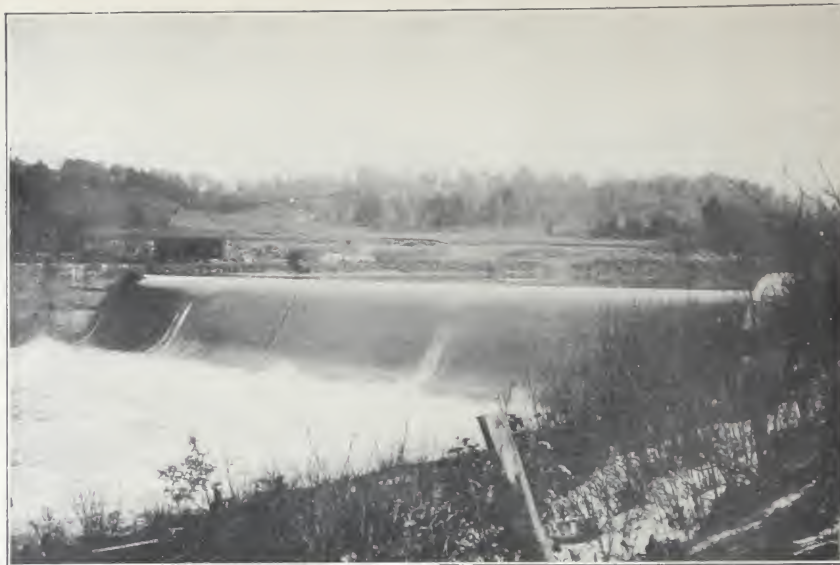
PLATE 5.

PLATE 5 was taken about March 26, with a flood of 4 feet 6 inches on the rollway. The night before this photograph was taken immense fields of gorged ice up to 44 inches thick went out. At times the ice would strand on the crest and pile up to a height of several feet until the force of the water carried it over.

PLATE 6 is a view through the interior bridgeway which forms the only means of communication between the mill and the railway station on the opposite bank. The bridgeway is well lighted and ventilated by the air drawn through the vents in the apron. It is in daily use by all the operators, officers and visitors. At the time the photograph was taken there were probably several people passing through the dam with 4 feet of water rolling over their heads, all of which may be appreciated by referring back to Plate 5.

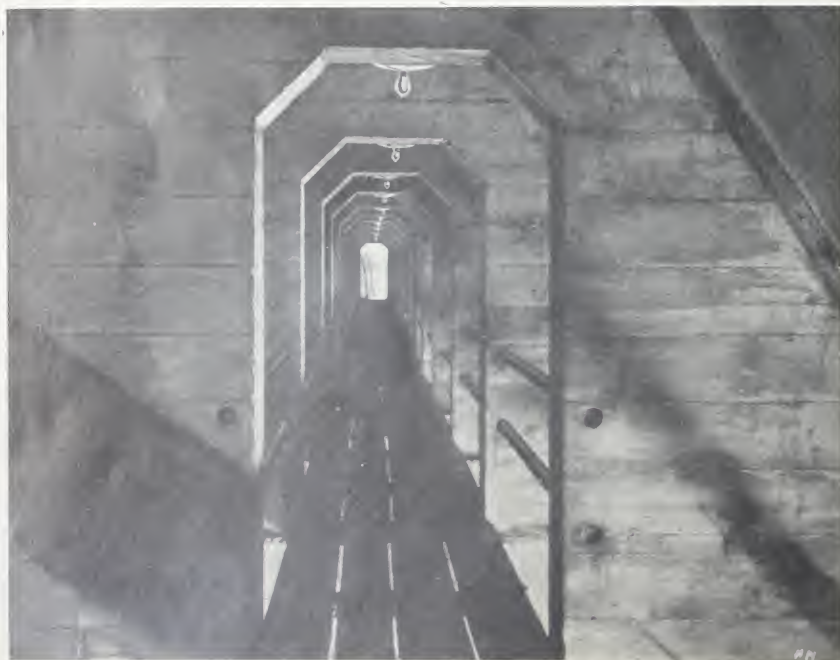
PLATE 6.

The absolute silence on the interior of the dam contrasted with the roar of the water outside was as remarkable as unexpected. This bridge is not a "freak" but a thoroughly practical application of the properties of the dam and has been substantially repeated by us in nearly every subsequent structure.

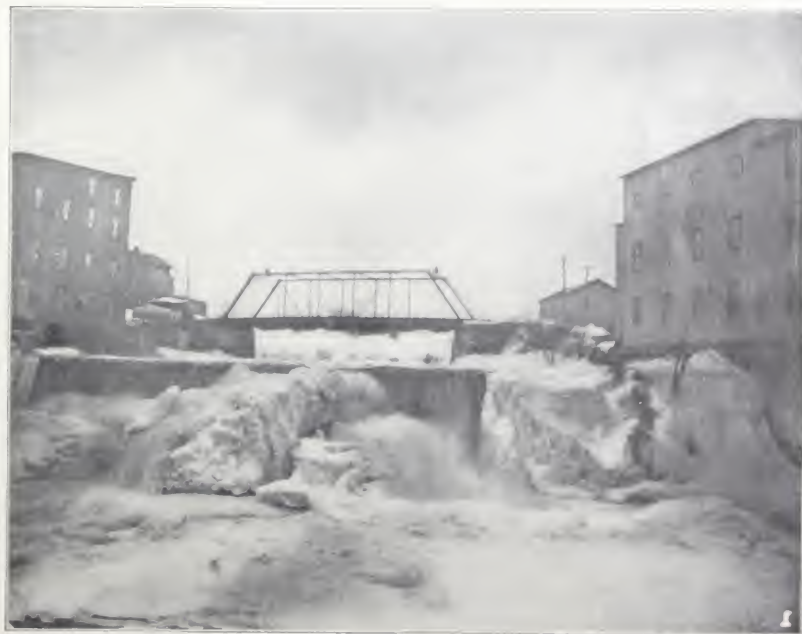
PLATE 8.

PLATE 8 shows the same dam laden with ice in the severe winter of 1903. During the spring of the following year ice 36 inches thick went over the dam. This photograph with others of a like character in this album effectually answers the question as to the behavior of reinforced concrete in the winter season.

This illustrates the first concrete-steel dam ever built. It was designed by the predecessors of this Company, Messrs. Ambursen & Sayles, formerly of Watertown, N. Y., and was built in 1903 for a flour mill on the Indian River.

Length 125 feet. Maximum height 15 feet.

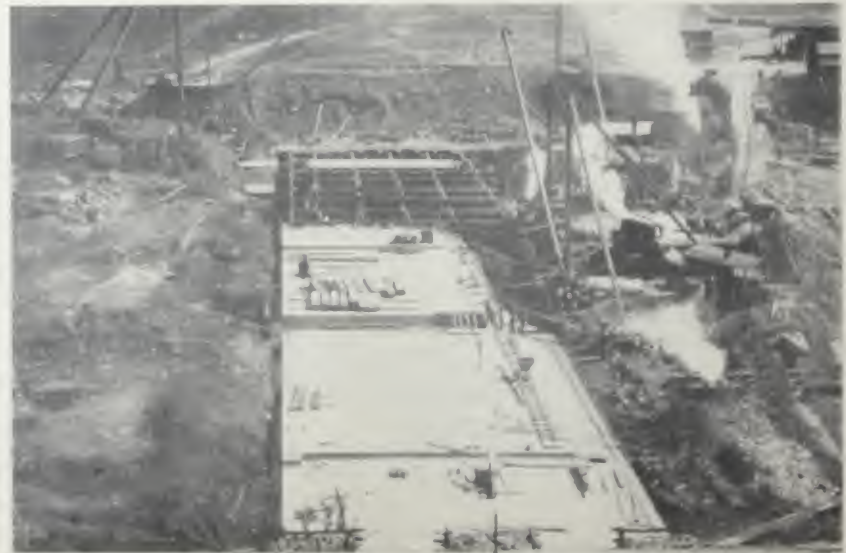
PLATE 12.

PLATE 12 is a view from the other end of the dam and shows the floor almost completed, ready for the reception of the buttresses. The floor is stepped up at different points to accommodate the slope of the ground and save material while the discharge lip of the apron is kept level notwithstanding.

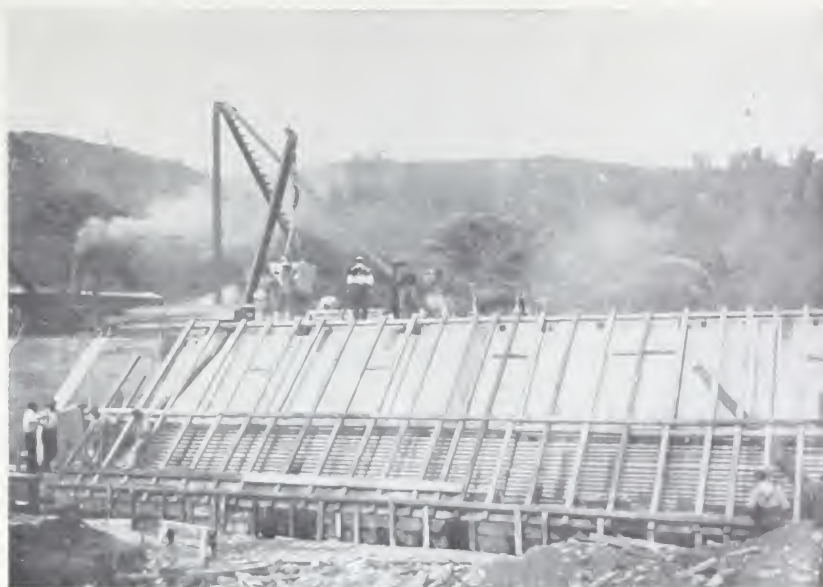
PLATE 13.

PLATE 13 shows the reinforcing rods and lower deck forms in place.

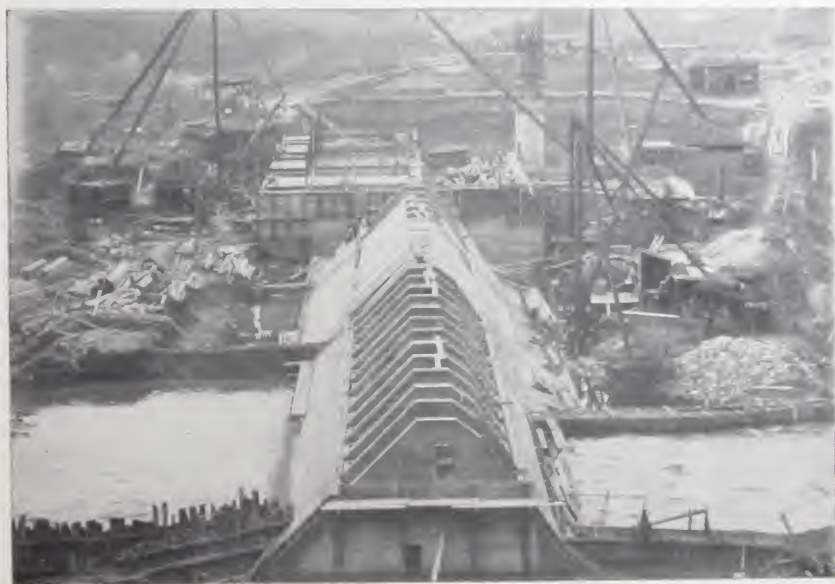
PLATE 14.

PLATE 14 is a bird's-eye view showing one-half of the rollway in an advanced stage of completion. The water is passing through the sluice openings without interrupting the work overhead. The buttresses are plainly shown and parts of the deck in place.

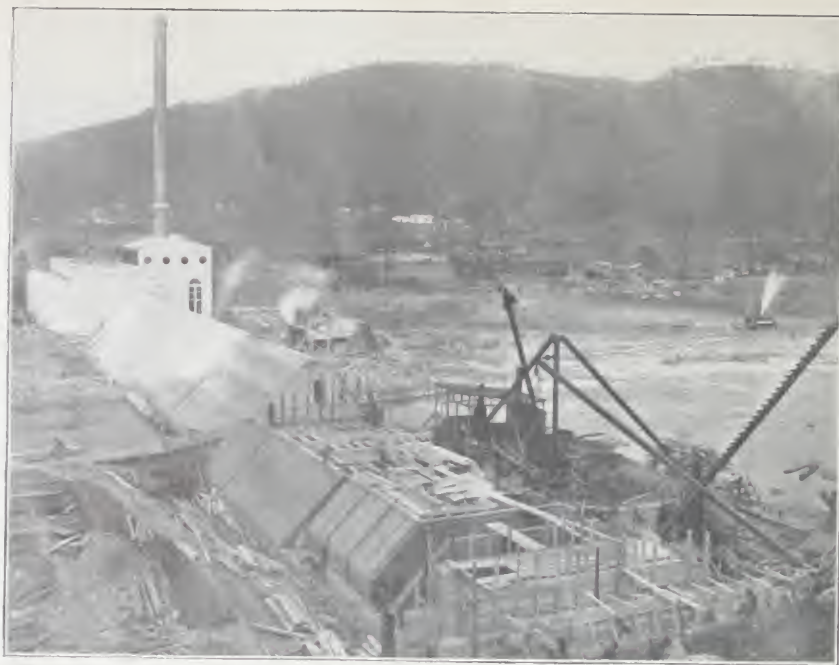
PLATE 15

PLATE 15. This cut which, like the others, is merely from a series of progress photographs, shows the dam in all stages of construction. In the foreground the buttress forms are set up and in the second section the steel is in place ready for laying the deck. In the next section a portion of the deck is in place. Beyond the coffer dam is shown a completed section of the dam with power house.

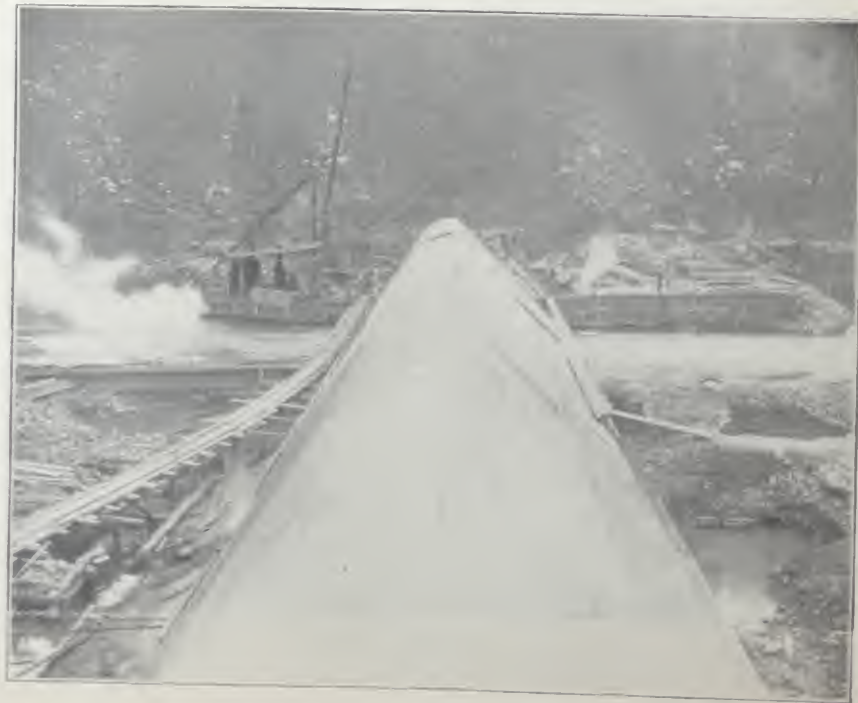
PLATE 16. This is a view of the completed half of the rollway looking outward from the power house. It gives an admirable idea of the obvious stability of the whole structure. We regret that we are obliged to go to press before we can show pictures of this dam under flood

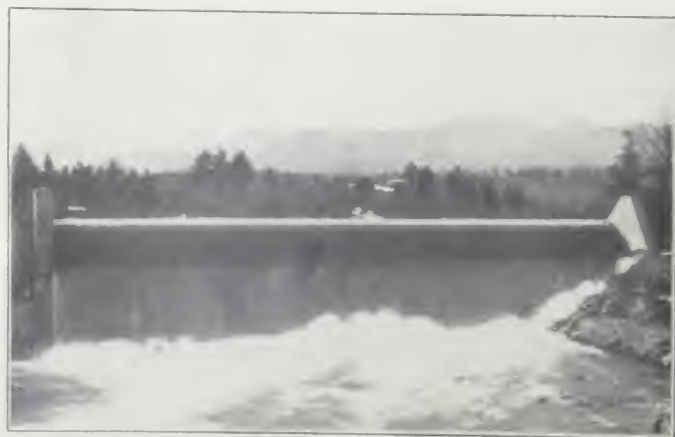
PLATE 20.

This is a dam 28 feet high and 200 feet long in the rollway, built for the Cairo Electric Light & Power Company, across the Catskill River about two miles from Cairo, New York. The Stevens-Hewitt Engineering Company, Park Row Building, New York, were the engineers for the company.

It is a Curtain Dam on a rock foundation, and is subject each year to an attack of heavy ice gorges. The power house is some 1200 feet below the dam and the water conveyed thereto by penstocks, the head joints of which are shown.

PLATE 20 is a view of the dam under flood.

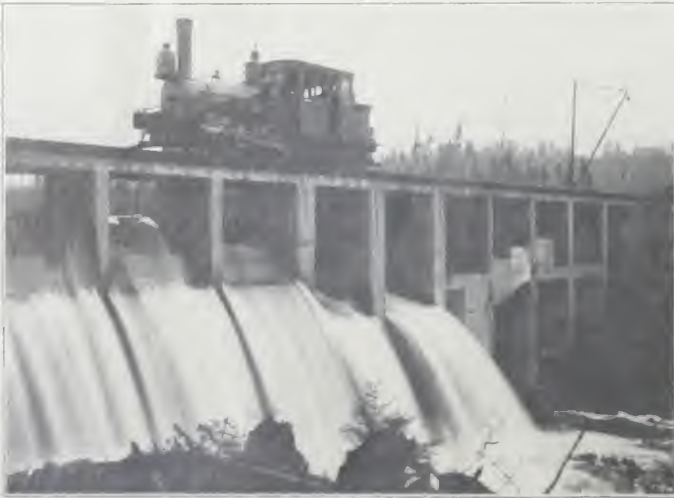
PLATE 31 shows three bays of the rollway, the log sluice, and beyond that the fishway.

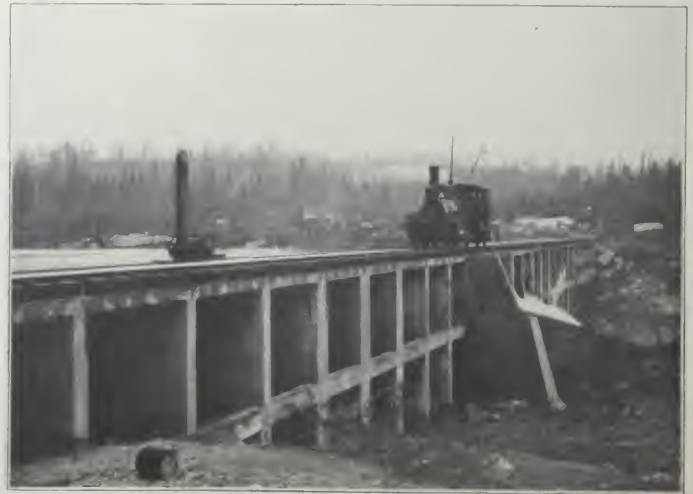
The special feature of this dam is that it also forms a bridge for a steam railroad.

PLATE 32 is a general view of the dam and both photographs show the locomotive in position over the rollway.

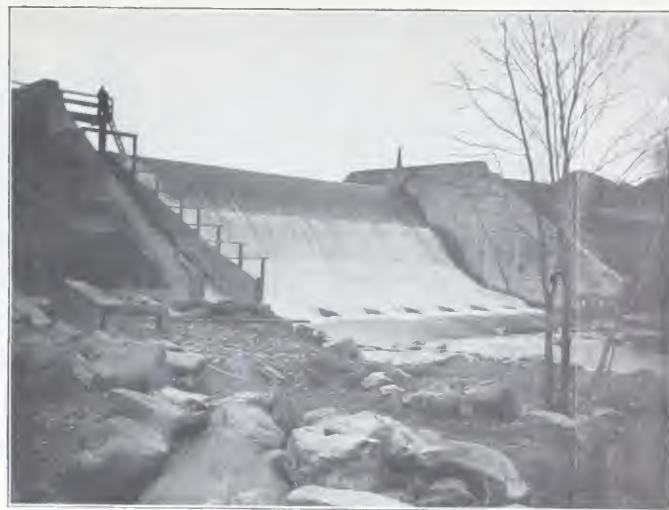
PLATE 33

The means used for a future increase of height are shown in the sectional cut. The buttresses are carried up to the 30 foot grade and the front edge stepped off as shown, with corrugated rods left projecting from the edges. A temporary plank apron carries the water, logs and ice and protects the rods.

Later on when the dam is to be raised the apron is removed, buttress forms set up and the dam carried up to its full height. The added section is self-stable without the rods but of course the rods bond the whole structure into a single monolith the same as if originally so constructed.

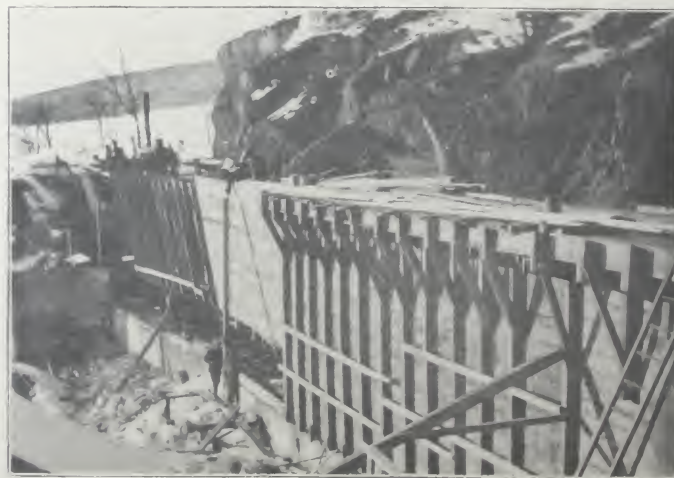
PLATE 45 shows part of the bottom and the forms for the wall in place with the cantilever reinforcement appearing.

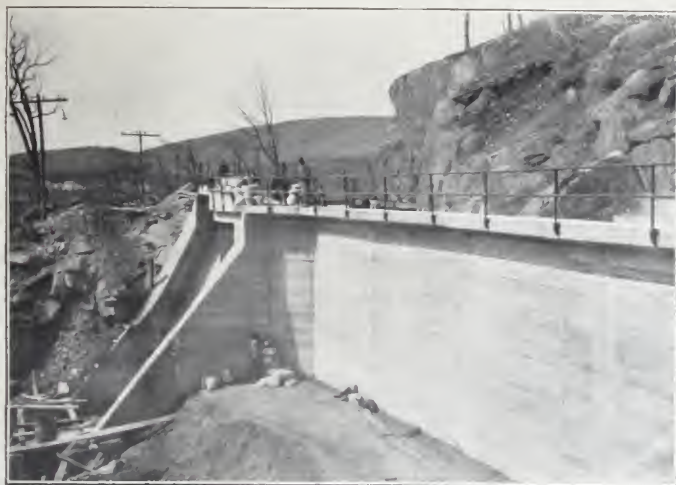
PLATE 46 is a portion of the completed structure with the waste gate between the two buttresses.

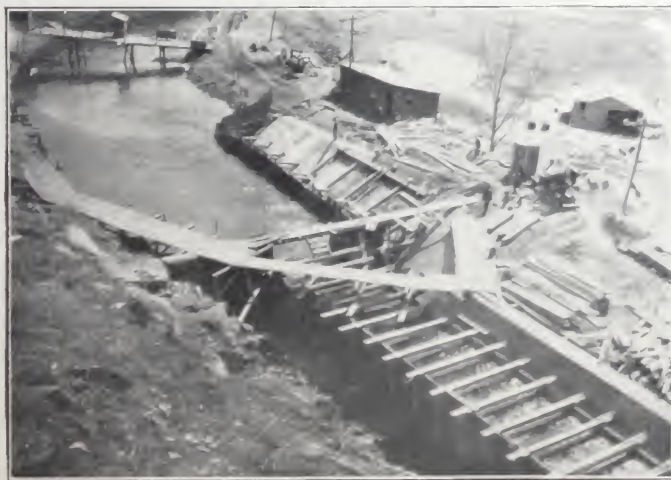
PLATE 47

Up to this stage the work has been carried on around the temporary structure so that it now presents the appearance shown in Plate 47. It will be noted that the concrete flume is prolonged into a wall joining the flume by a warped surface.

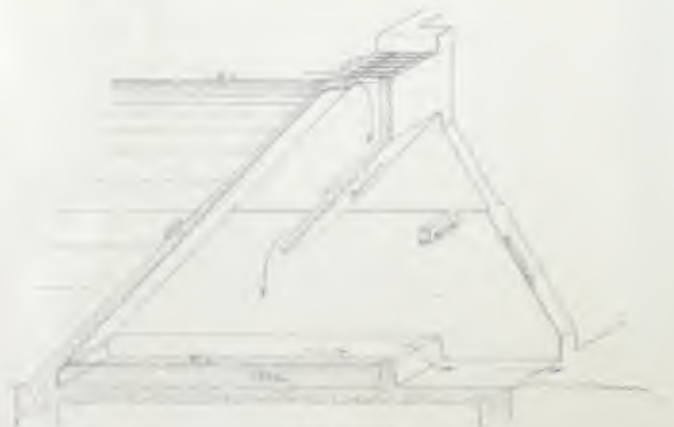
PLATE 62.

The spill-way is especially unique and effective, as illustrated on enlarged scale in Plate 62. The flow of the stream being very small, even in flood, the spill-way is confined to three bays, aggregating 30 feet in a total length of 200 feet. A baffle of reinforced concrete is built between the buttresses and the space between the lip of the dam and the edge of the baffle is screened by a grid of $1\frac{1}{2} \times 3$ inch steel on 12 inch centers, bedded in the concrete.
